ABSOLYTE[®]
TECHNOLOGY
Professional Paper

Battery Energy Storage System
(BESS)

Achievements of an ABSOLYTE® Valve-Regulated Lead-Acid Battery Operating in a utility Battery Energy Storage System (BESS) for 12 Years

George Hunt and Joseph Szyborski
Exide Technologies
Aurora, Illinois USA

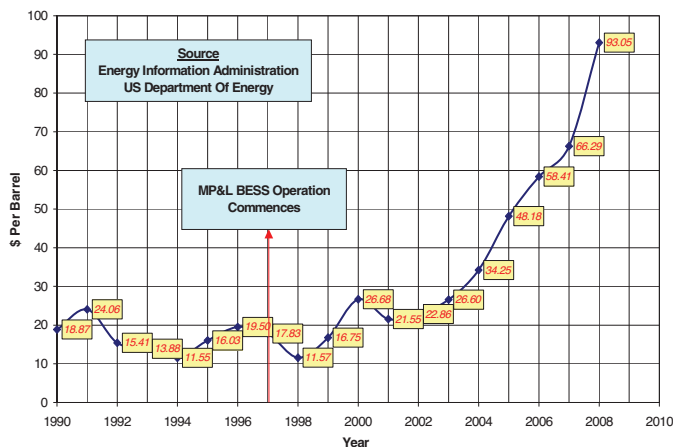
Figure 1. Estimates of the economic benefit of the MP&L BESS uses data reported by the US Department of Energy for the spot market price for crude oil.

Fuel oil costs are based on the spot market prices reported by the Energy Information Administration of the US Department of Energy [2]. The annual average price per barrel of oil from 1990 through 2008 (shown in the following graph) rose from less than \$20 per barrel when the BESS was initially installed to more than \$90 per barrel in 2008 (**Figure 1**).

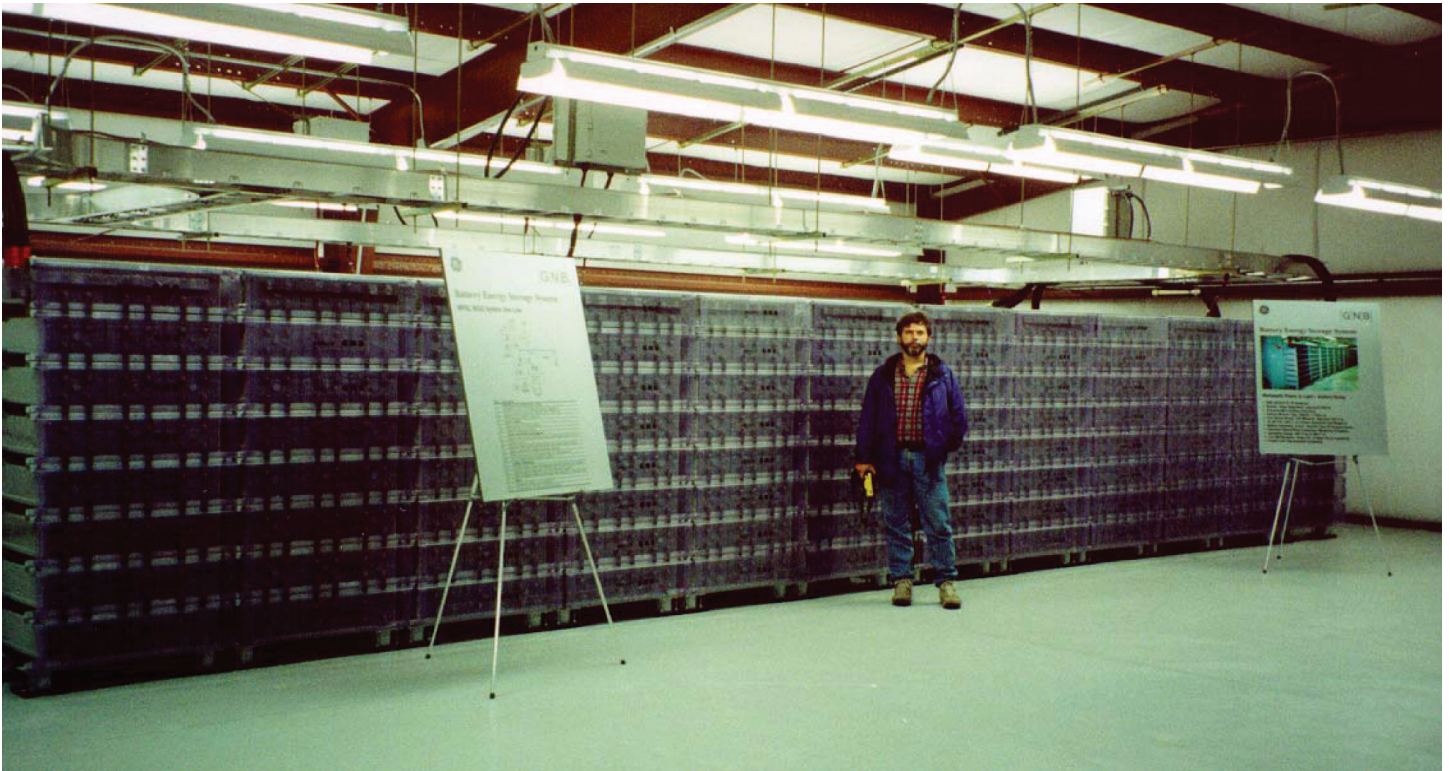
Figure 2. The battery at the MP&L BESS consists of 378 Exide ABSOLYTE® IIP 100A75 modules connected in series rated to deliver 1.4MWh at a 1.0MW discharge rate at a nominal 756 volts.

The battery's 378 modules were arranged in two back-to-back rows, each row comprised of twelve stacks of ABSOLYTE® modular trays eight high, separated by an aisle. The battery was positioned to minimize cable runs between rows of battery stacks and to the power conversion equipment. Pilot cell voltage and temperature measurements are made at locations strategically positioned throughout the battery bank. A fan was installed to circulate air in the building and to maintain a consistent temperature. A heater is used to warm the facility during the colder winter months and to reduce humidity.

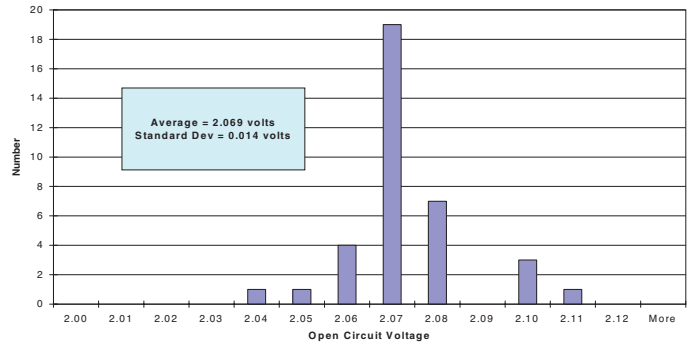
Figure 3a. Histogram of “As Received” Open Circuit Voltage of cells returned from the MP&L BESS.

The measured open circuit voltages were consistent with a partial state-of-charge condition as was anticipated; the voltage of a fully charged ABSOLYTE® VRLA cell should be 2.15 – 2.17 volts. The measured impedance values were not abnormally high. Furthermore, both measures, OCV and impedance, were “normally” distributed around the average, indicating a reliable statistical sampling of the MP&L BESS battery set.

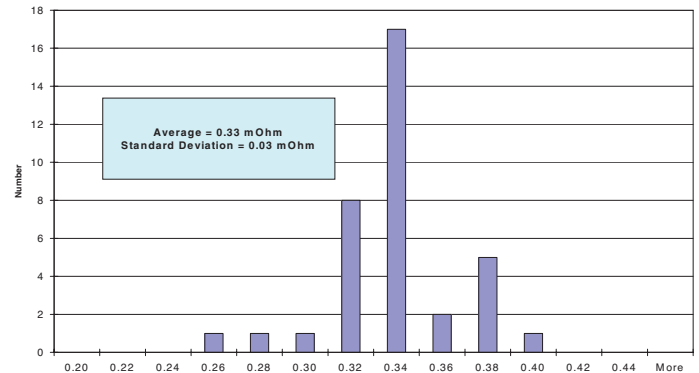
Figure 3b. Histogram of “As Received” Internal Impedance of cells returned from the MP&L BESS

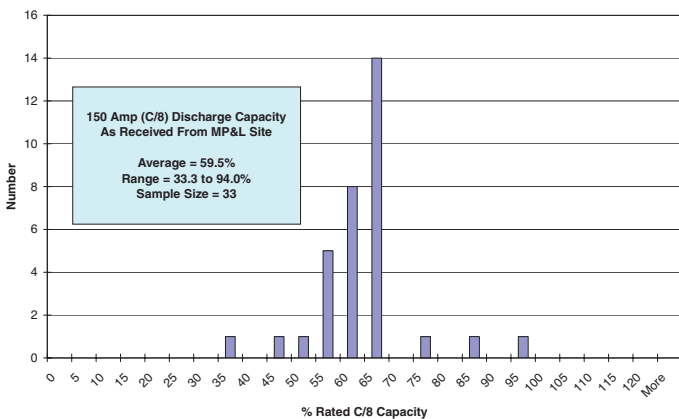
The cells delivered an average C/8 capacity of 59.5%, ranging from a low capacity of 33% to a high capacity of 94% (**Figure 4a**). These results indicate that the MP&L control algorithm was indeed maintaining the battery at the desired state-of-charge. Measurements of electrode potentials made using a reference electrode indicated that the negative electrode was in general, limiting the capacity of the cells.

Figure 4a. The discharge capacity of the MP&L cells “as received” from the site averaged 60% at the C/8 discharge rate, indicating the BESS control algorithm was maintaining the cells in the desired partial SOC operating range.

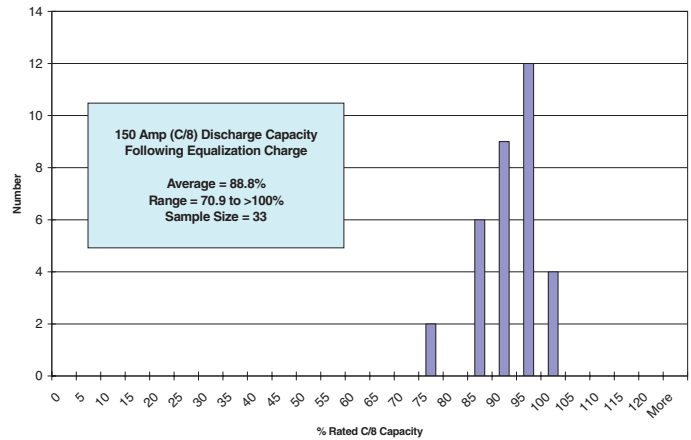
Following this discharge, the cells, still connected in a single series string, were given an equalization charge as a group. The purpose of this test was to determine the effectiveness of the recharge method employed at the MP&L BESS after each 6-month cycle to restore the battery to its nearly fully charged state. The sample field-aged cells were then again discharged at the C/8 discharge rate yielding an average capacity of 89% ranging from a low capacity of 71% to cells delivering greater than 100% of the rated capacity (**Figure 4b**).

Figure 4b. Following an equalization recharge similar to that given the MP&L battery every 6 months, the capacity of the sample cells increased to nearly 90% at the C/8 discharge rate, demonstrating its recovery from the partial state-of-charge operating regimen.

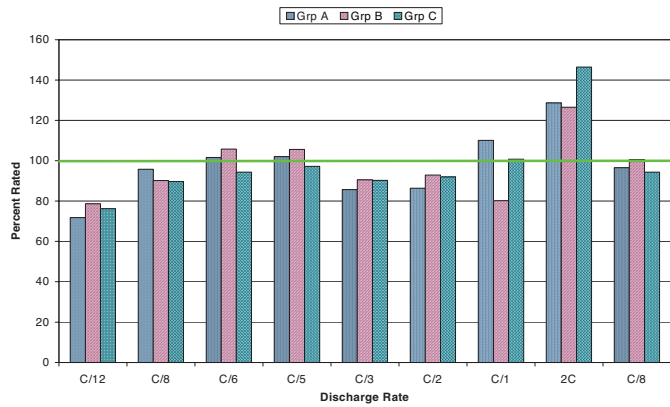
In general, capacity developed significantly over the first 2-3 test discharges indicating that any short-term capacity deterioration was readily reversed by a few cycles with adequate recharging. After the first test discharge, the average capacity of the samples was above 90%; and by the final test discharge after several additional cycles, the average capacity of the samples improved to 97% of rated. Even at the highest discharge rate (i.e., the 2C

Figure 5. Characterization discharges of the MP&L samples indicate an overall better than 95% of rated capacity over the entire range.

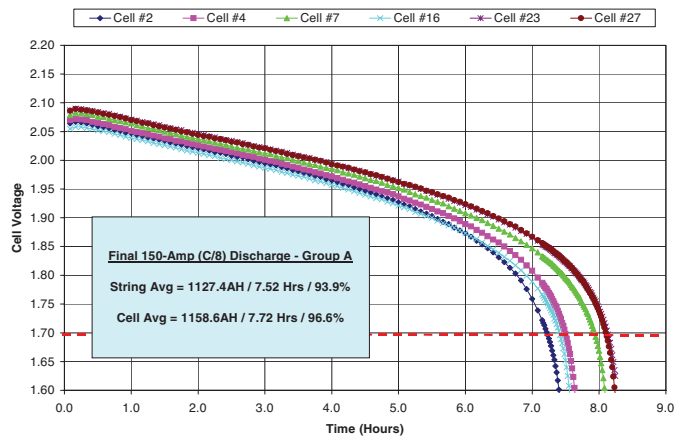
Figure 6a. Voltage of MP&L cells during final C/8 rate test discharge is consistent and strong.

The cell voltages during these discharges were “strong” and typical for the rate at which the cells were being discharged (Figures 6a and 6b).

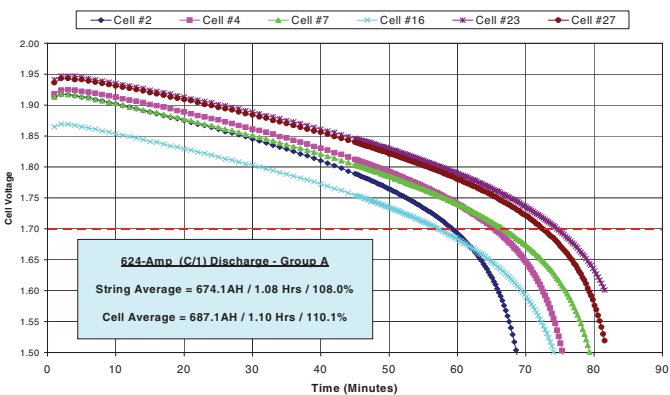
Figure 6b. Even at the higher C/1 discharge rate (624 Amps), cell voltage is strong and consistent.

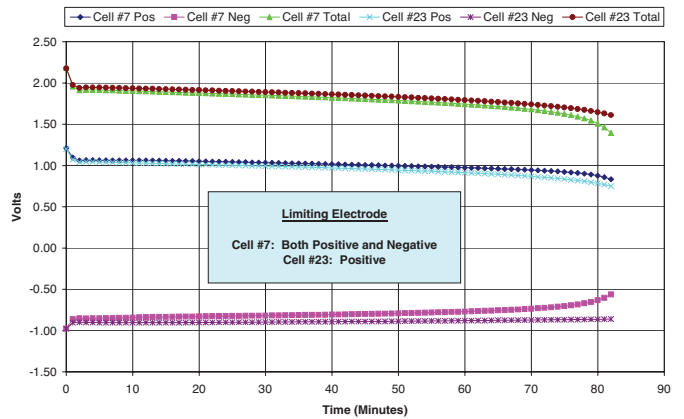
Individual electrode potentials measured using a reference electrode showed the limiting electrode changing from the negative initially, to either the positive electrode or both electrodes as anticipated by the cell’s design (Figure 6c).

Figure 6c. With cycling over the course of the rate characterization tests, the limiting electrode was determined to change from the negative to either both electrodes or the positive electrode as would be expected by cell design.

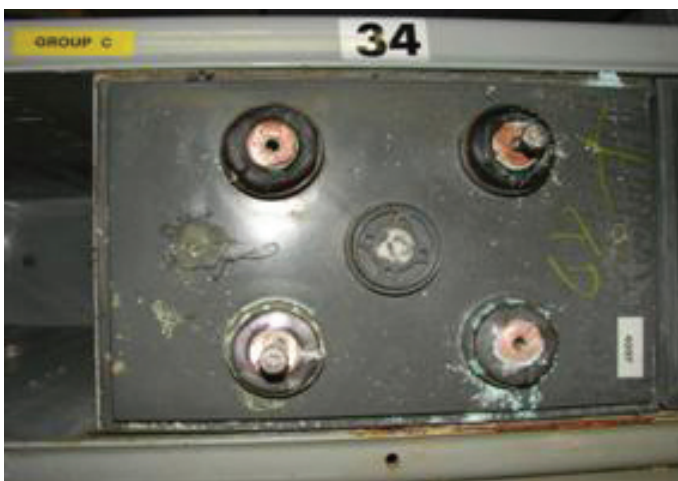
Some of the cell terminal posts showed signs of electrolyte weeping or leakage (**Figure 7**), ranging from a slight discoloration on either the plastic surrounding the terminal post bushing or the lead surrounding the copper insert to dry whitish corrosion material either at the interface between the copper insert and the lead bushing or the lead bushing to the plastic cover. These observations were not surprising since this issue with terminal post “weeping” was identified about a year after the initial installation. As predicted at that time, the corrosion materials dried on the slightly wetted lead surfaces and eventually blocked further release of any electrolyte. In all cases the corrosion was halted before it caused any significant damage to the copper insert that carried the electrical current, and to which the intercell connections are bolted.

When this issue was first discovered, the cause of the electrolyte weeping was determined to be related to a specific lot of terminal post bushings, a cast lead part molded into the cell cover to which the terminal post is welded. Porosity in the bushing allowed some electrolyte to weep through the casting to the surface causing the lead to discolor and oxidize. In some cases, as seen in the top left-hand terminal post in **Figure 7**, cracks in the bushing occurred. Although cosmetic appearance could be described as being “ugly”, functionality of the cell was not impaired.

Figure 7. Terminal post corrosion was observed on several cells caused by electrolyte weeping through the cover bushing. The current carrying copper inserts remained undamaged.

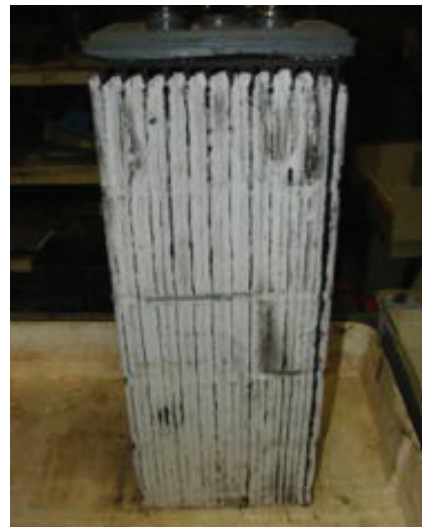
Figure 8. The cell elements of all samples examined were in excellent condition with no torn separators or exposed plates. Banding was used to maintain plate alignment and separator compression.

The condition of all of the cell elements examined was excellent. There were no torn separators, and the edges of all of the plates were adequately covered. Notable was the fact that there was no noticeable positive plate growth, which would be exhibited by the positive plates extending beyond the edges of the separator and above the separator at the top of the cell element. The banding wrapped around the cell element to maintain alignment of the plates and compression of the separator material was in place and still taut around the element. There was no free liquid electrolyte in the bottom of the cell container.

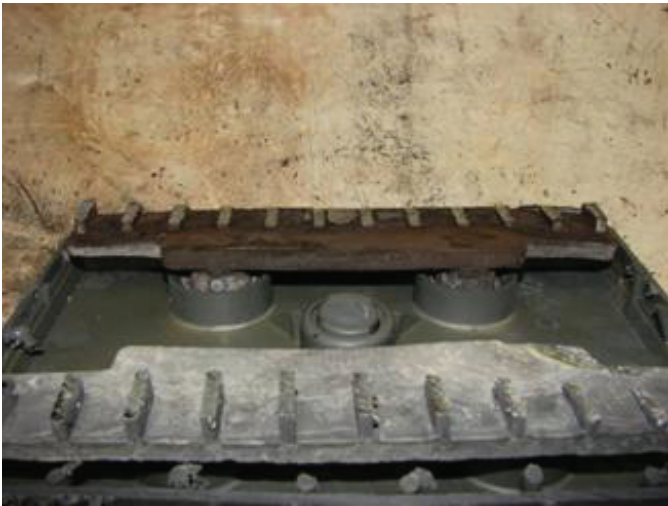
Figure 9. Examination of the cell's internal lead hardware shows no indications whatsoever of corrosion.

Both the positive and the negative busbar assemblies were in excellent, almost like new, condition. The negative assembly had a slight dull gray coloration on its surface indicative of some oxidation and sulfation, which was only on its surface. All of the lug welds were firmly connected. The positive assembly had a brownish coloration on its surface indicative of some lead dioxide formation. Again this oxidation was only on the immediate surface of the lead; a light scraping revealed clean, bright lead metal just below the surface of this oxidation. It was quite obvious that these busbar assemblies would have been suitable for many more years of use.

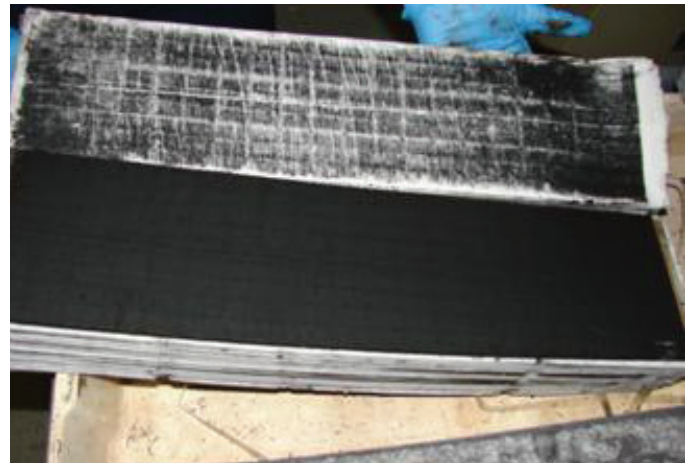
Positive plates from the rate characterization cells, which received up to ten discharge-recharge cycles, had a very dark chocolate brown color. There was no surface sulfate. There were no loose active material pellets and the pellets were solid throughout. The active material was moist but not soft. Overall the condition of these positive plates was excellent (**Figure 10a**).

Figure 10a. Positive plate from a cycled MP&L sample cell has a dark brown color and is in excellent condition.

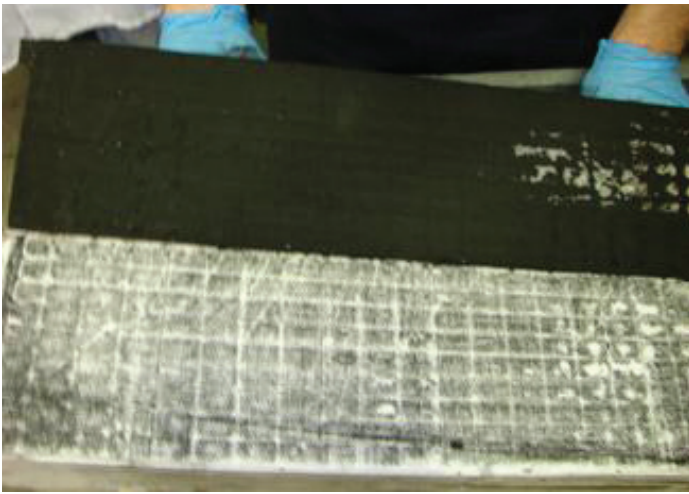
Positive plates that were removed from the cells that had not been charged or tested at Exide's labs, but were in the same condition as they had been removed from the MP&L site, were still a very dark brown color. However, on some of the plates there were small patches of white surface sulfate (**Figure 10b**), which could be easily scraped away to reveal dark brown active material below. A few of the pellets were loose and were easily pushed out of the grid. Pellets were brittle and could be cracked in half.

Figure 10b. Positive plate from an MP&L cell as removed from the site shows a small amount of white surface sulfate, even though it has a mostly dark brown coloration.

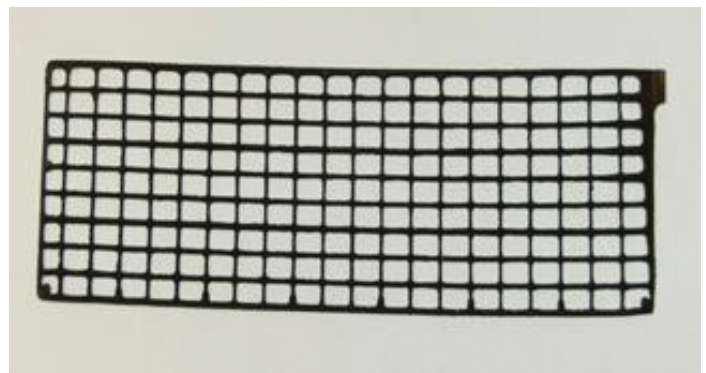
Another surprising observation made during these examinations was the overall strength and integrity of the positive plates. Typically the normal ageing process in a lead-acid battery is directly associated with the corrosion of the cell’s positive grid. This corrosion is the chemical and electrochemical oxidation of the lead of which the positive grid is made, and the rate of which is a function of the electrolyte concentration, the potential applied and the amount of charge that the cell has received. As corrosion progresses, the cross sectional area of the wires in the positive grid becomes smaller, the grid becomes weaker and more fragile, and cracks in the grid’s structure cause sections of the plate to break apart. About half way through the life of a lead-acid battery, it is not uncommon for the positive grid to exhibit this fragile condition and to break apart when lifted from the cell assembly stack. None of this occurred during the examination of the MP&L samples; the plates appeared as if they were removed from a much newer cell than the actual 12-year age of these MP&L samples (**Figures 11a and 11b**).

Figure 11a. Positive grid removed from an MP&L BESS cell after 12 years of operation is still fully intact. It is typical at this age for positive grids to have become brittle and fragile, and to easily crumble with handling.

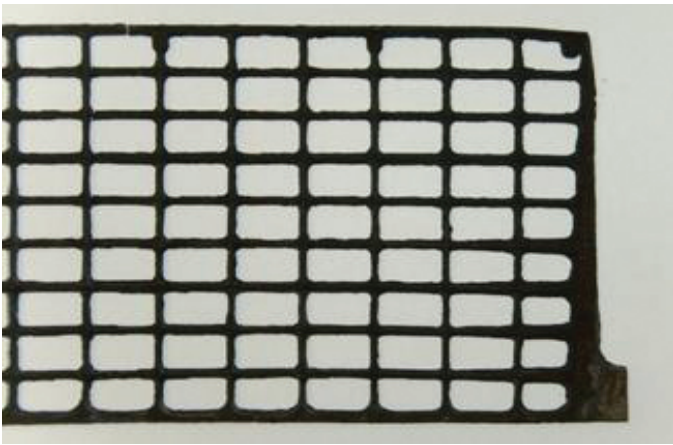
Figure 11b. Close-up view of upper section of the grid shows the grid wires and frames free of cracks and breaks that would typically appear in a cell after 12 years of operation.

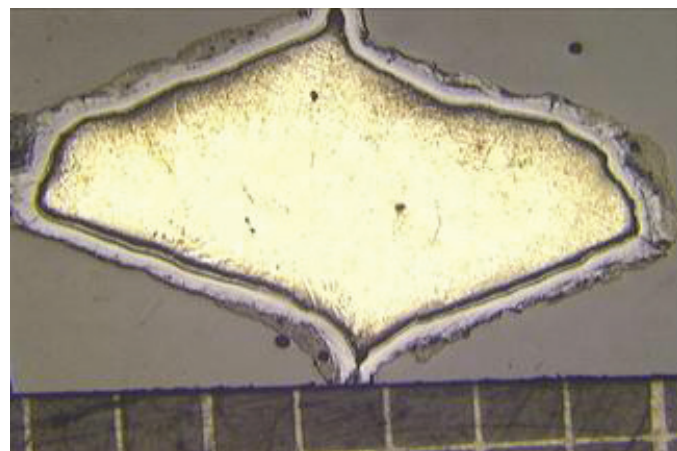
Figure 12a. Photomicrograph of positive grid cross section from cell replaced at the MP&L BESS after 11.6 years of operation, showing the corrosion layer uniformly surrounding the hard lead metal center.

Although the corrosion layer is noticeably thicker after 11.6 years of operation, there is still a very large cross section of hard lead metal still remaining in the grid member. These photomicrographs and the following analysis indicate grid corrosion not to be limiting life in this application.

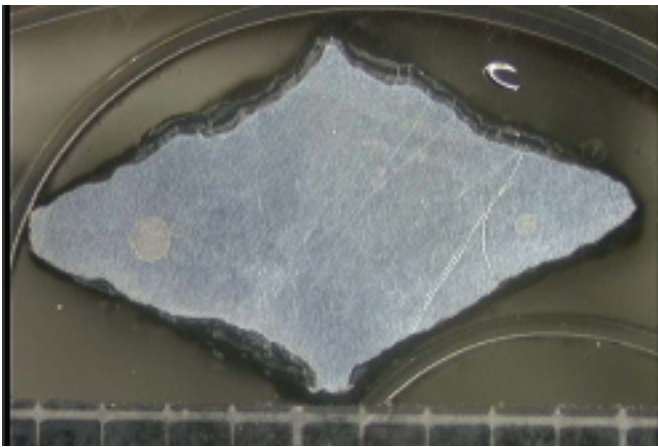
As comparison, **Figure 12b** is a photomicrograph of a similar section of a positive grid from a cell removed from the MP&L BESS in October 1999 and analyzed after only 30 months of operation as part of a Sandia National Laboratories / DOE funded study.

Figure 12b. Photomicrograph of a similar positive grid section examined after only 30 months of operation.
